Debris/Ice/TPS Assessment and Integrated Photographic Analysis of Shuttle Mission STS-95

**DEBRIS/ICE/TPS ASSESSMENT
AND
INTEGRATED PHOTOGRAPHIC ANALYSIS
OF
SHUTTLE MISSION STS-95**

29 October 1998

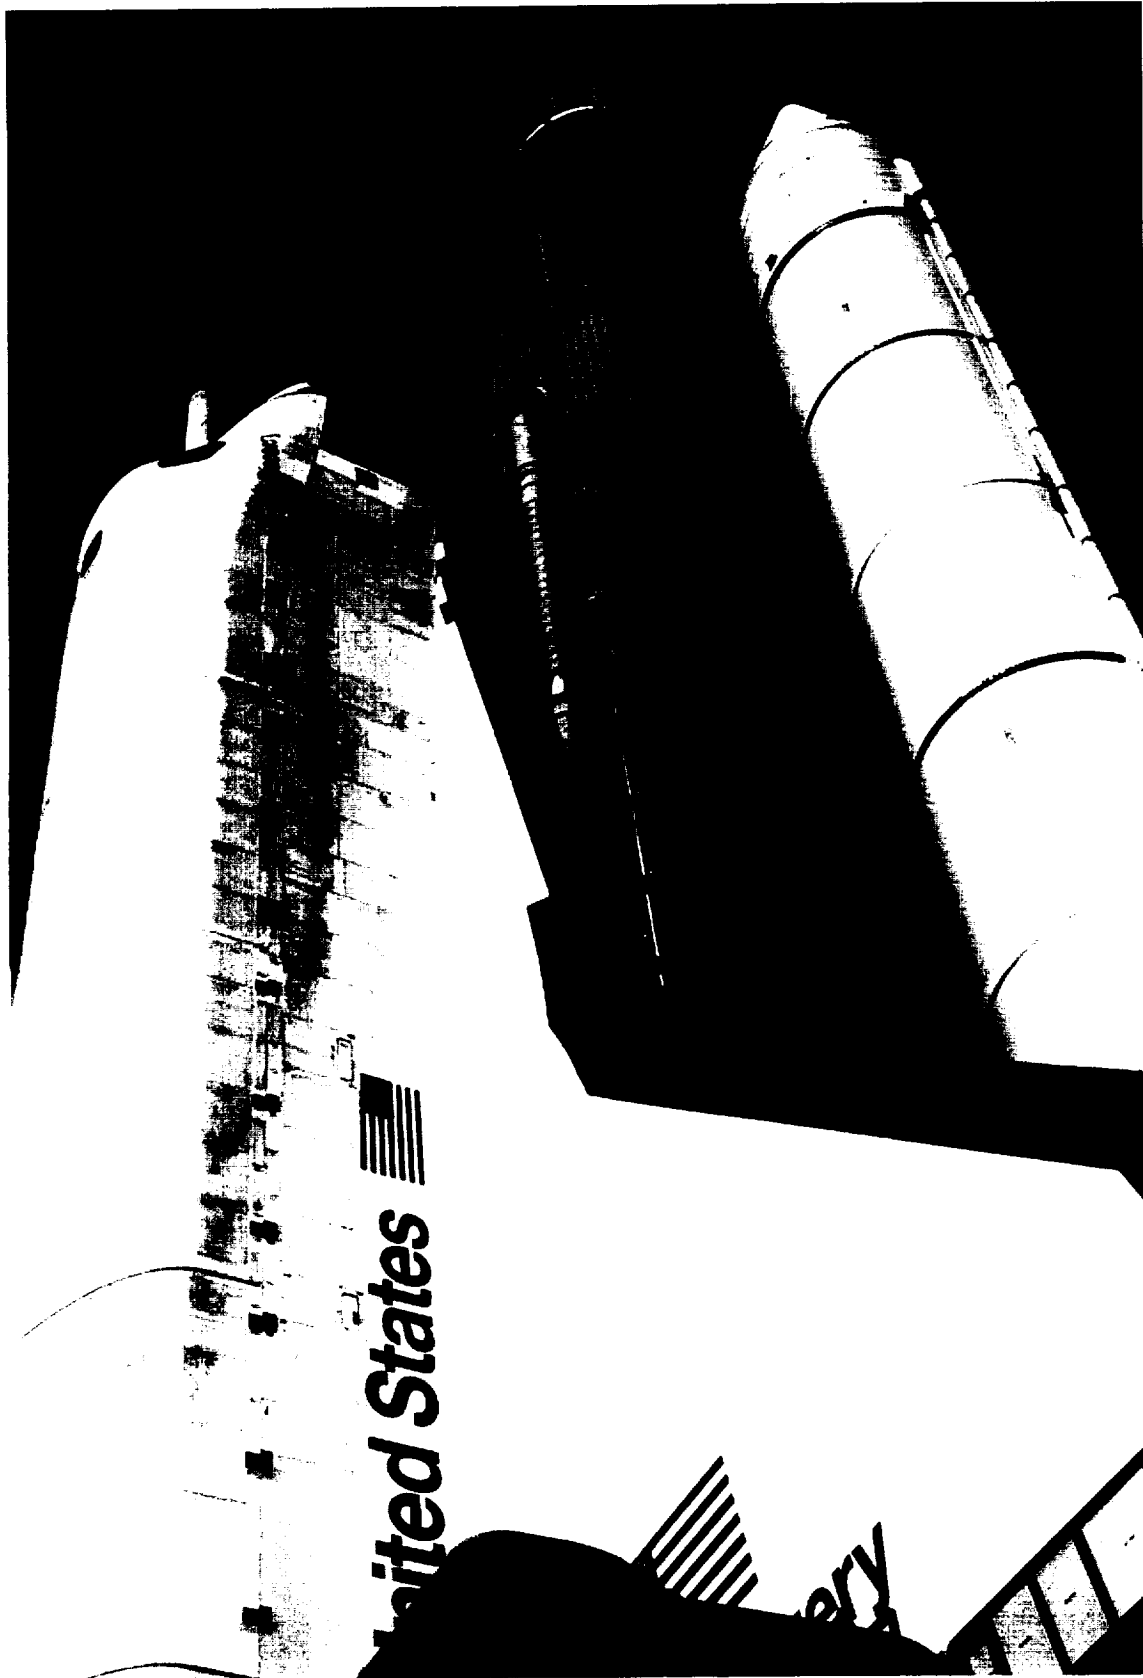
Photo 2: STS-95 Ready for Launch

OV-103 Discovery (25th flight), ET-98, and BI-096 SRB's on Pad 39B and MLP-2. The Final Inspection Team observed very light condensate, but no ice or frost accumulations, on the LH2 tank acreage. TPS surface temperatures ranged from upper 50's to low 60's degrees F.

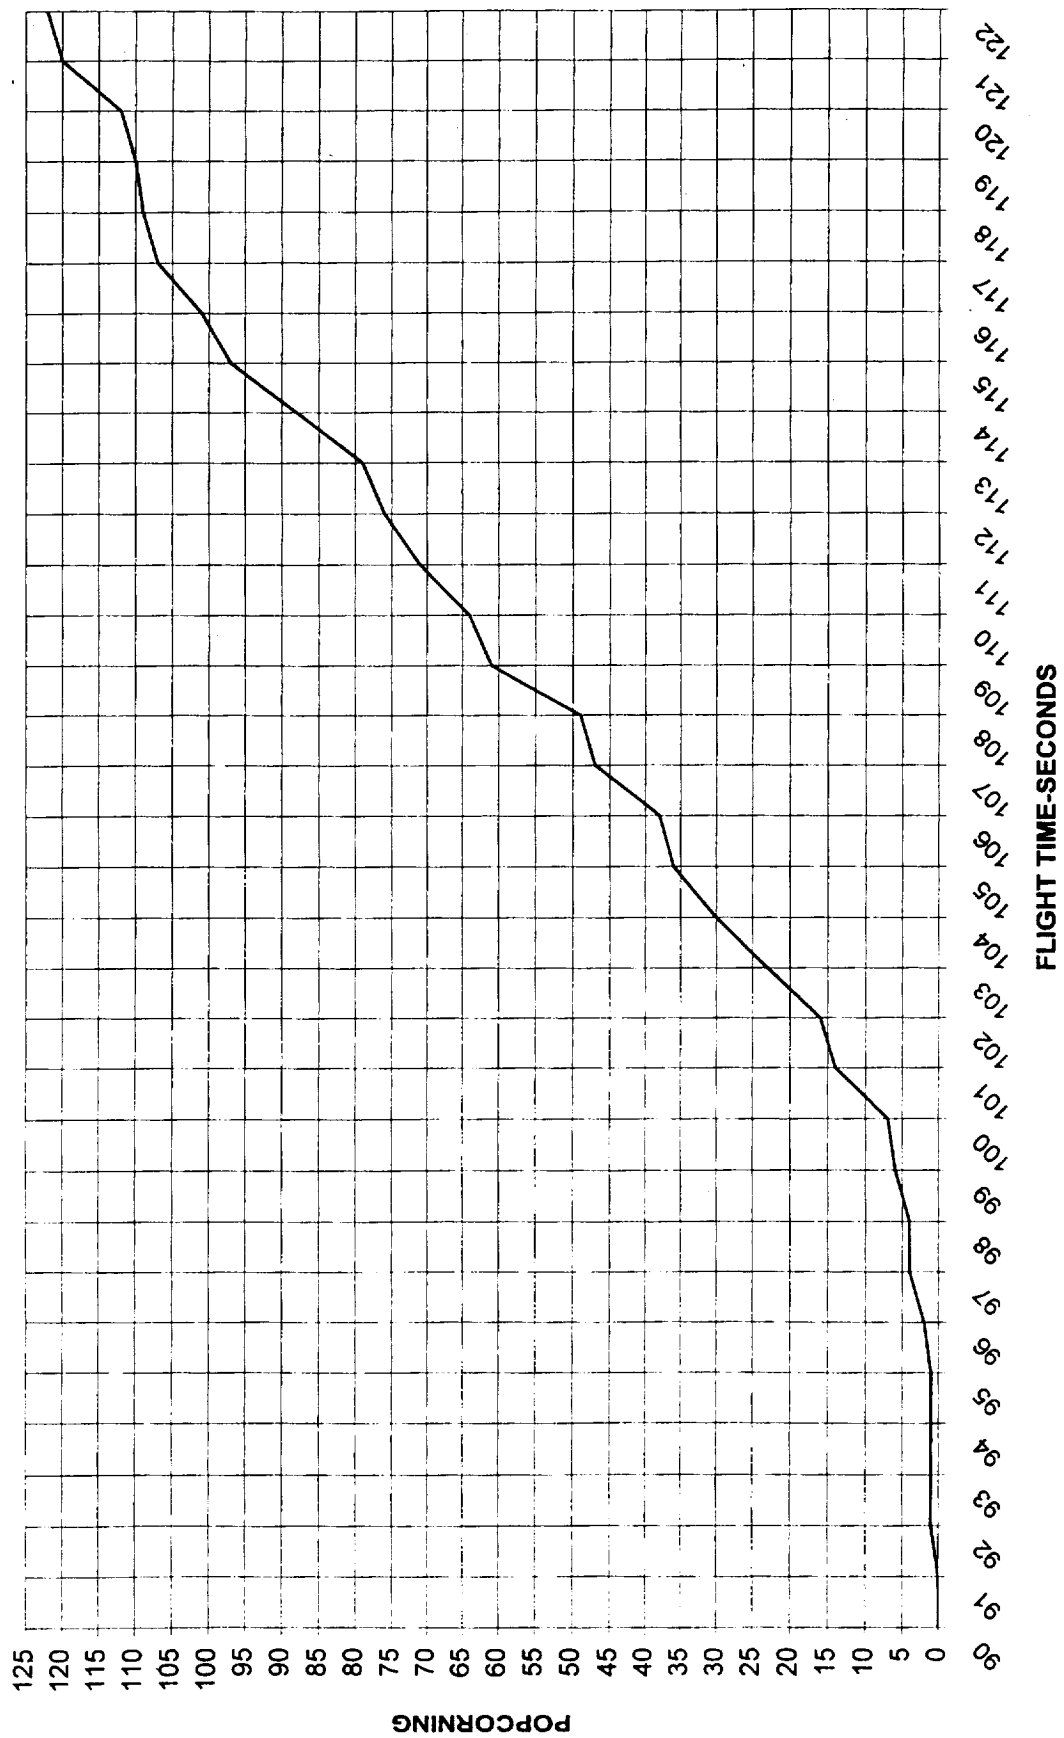
Figure 1: Number of Divots vs. Flight Time

Figure 1 shows the increasing number of divots from 92 seconds MET through SRB separation.

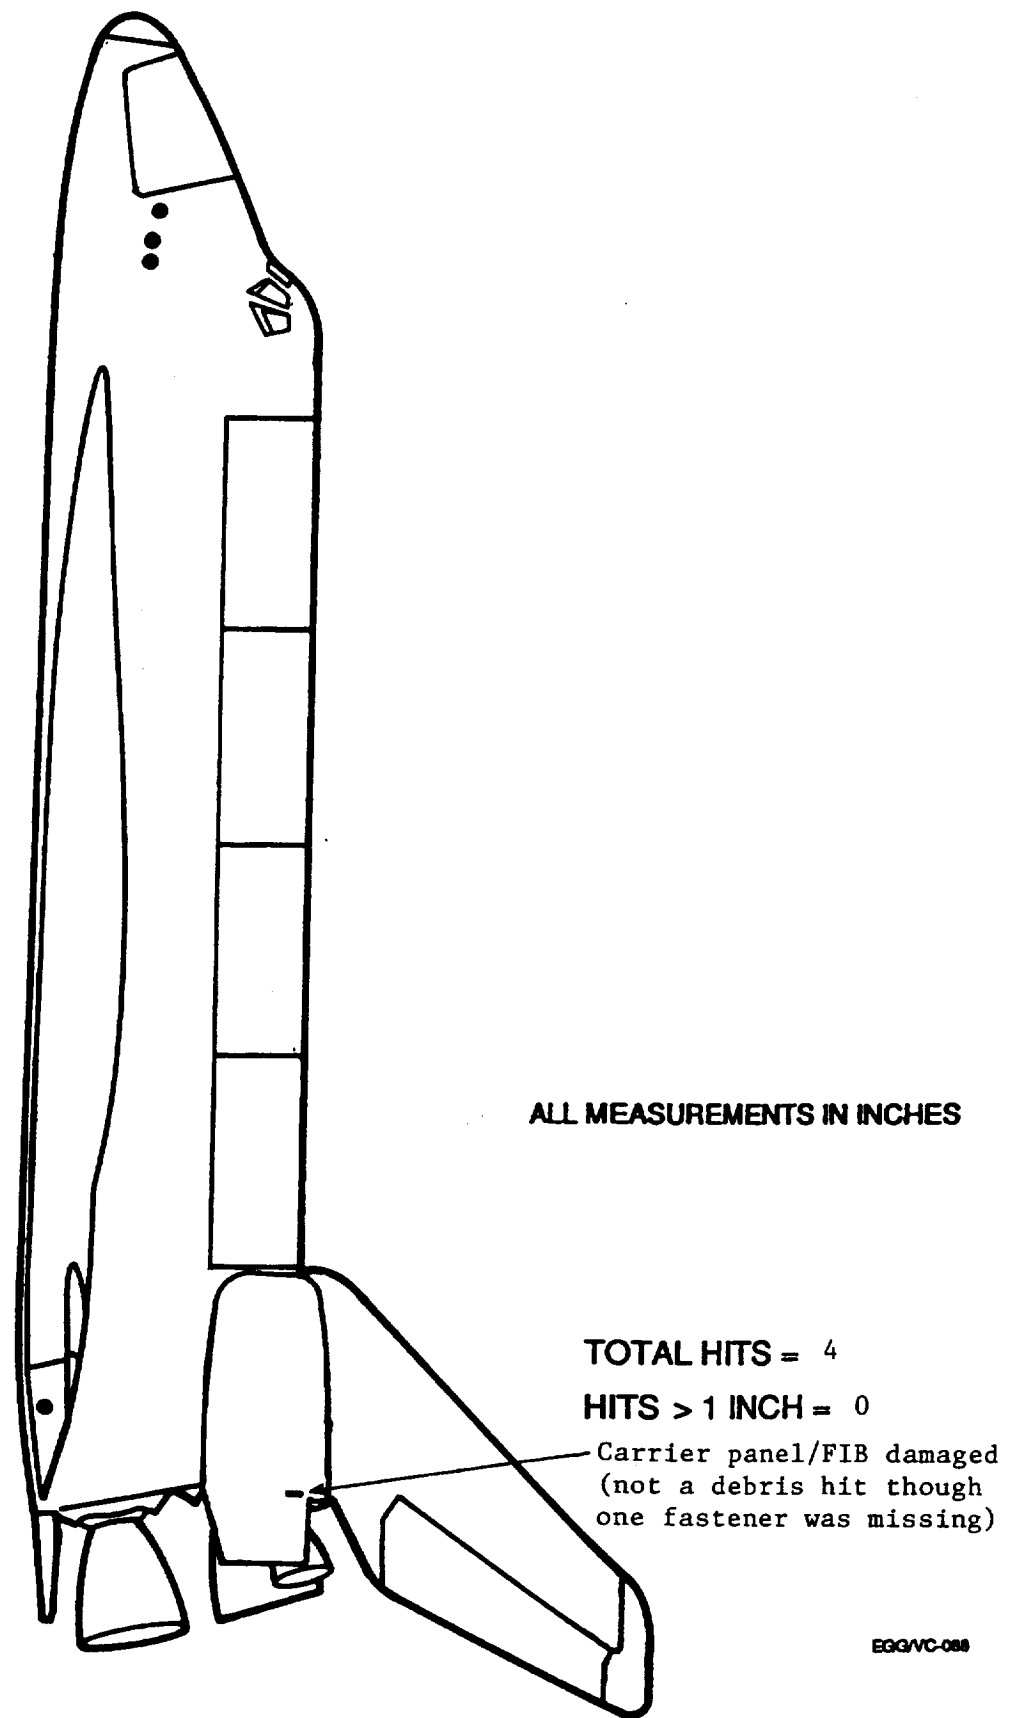
Figure 3: Orbiter Left Side Debris Damage Map

In summary, both the total number of Orbiter TPS debris hits and the number of hits 1-inch or larger was greater than the cumulative fleet average when compared to previous missions (Figure 5). Since the damage pattern and number of hits was related to the loss of TPS from the ET thrust panels (and therefore an identified debris source), these data were not incorporated into the cumulative statistics of hits and averages.

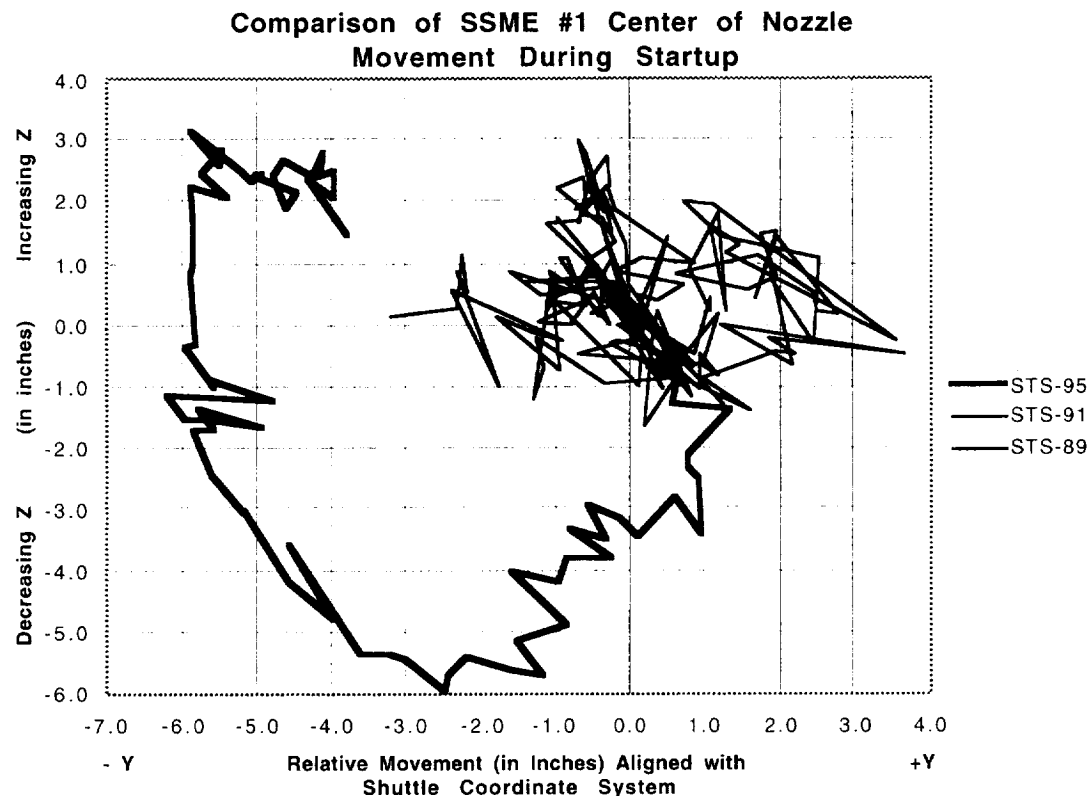
Figure 2.3.1.2 (E) SSME #1 Relative Motion Plots for STS-95, STS-91, and STS-89

Plots displaying the relative movement an observer would see in the center of the engine nozzle if they were positioned behind the vehicle looking forward at the SSMEs are shown in Figure 2.3.1.2 (E). The axes of the plots are oriented within +/- 5 degrees of the Y and Z axes of the Shuttle Coordinate System. The relative movement shown on each plot begins at the 0,0 coordinate location. The plots compare the magnitude of relative movement for each mission, but does not infer any absolute positional relationship between the SSME center locations during the three missions.

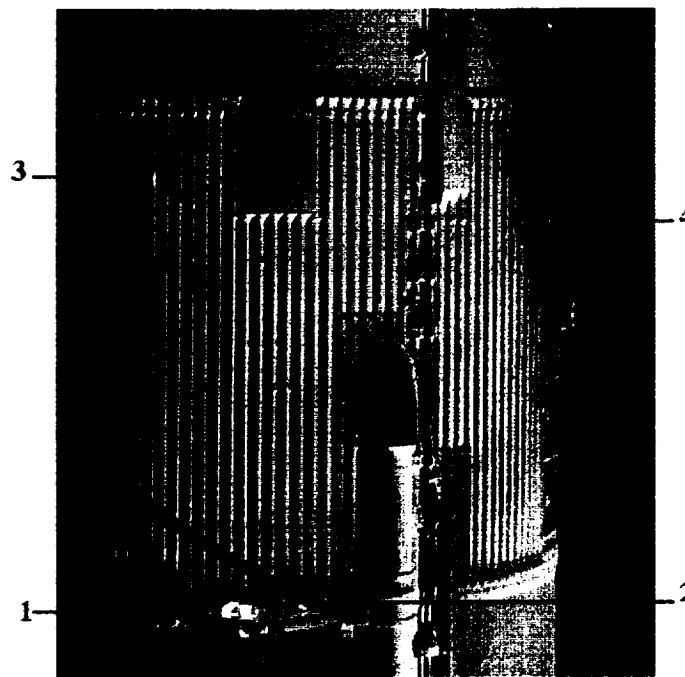
Figure 2.5.1 (A) 35 mm Umbilical Well Camera View of the ET Intertank

The LH2 tank and the LO2 tank/Ojive TPS appear to be in excellent condition on the close-up 35mm umbilical well camera film. The sanded area on the LO2 nose cone appears undamaged. Similar to STS-90, STS-91, and other previous missions, a gray-colored band of pock marked or possible missing TPS is visible on the +Z ET nose just aft of the ET nose cone fairing. Discoloration in this area is probably due to aero friction and heating. The RSRB separation motor burn scar appeared typical of previous missions with only a small area of possible very shallow divoting visible.

Two large divots (approximately 7 inches in size) are visible on the LH2 tank-to-intertank close out flange between the legs of the forward ET/Orbiter attach bipod (annotation 1). The divots have sufficient depth to show shadow but probably not primed substrate. A smaller third divot is visible on the same flange near the right (+Y) foot of the forward bipod (annotation 2). The bipod jack pad close-outs appeared intact. An intertank stringer head divot approximately seven inches in length is visible in the -Y direction from the +Z intertank aero vent (annotation 3). Approximately ten very small, randomly located, divots were counted on the intertank stringer heads.

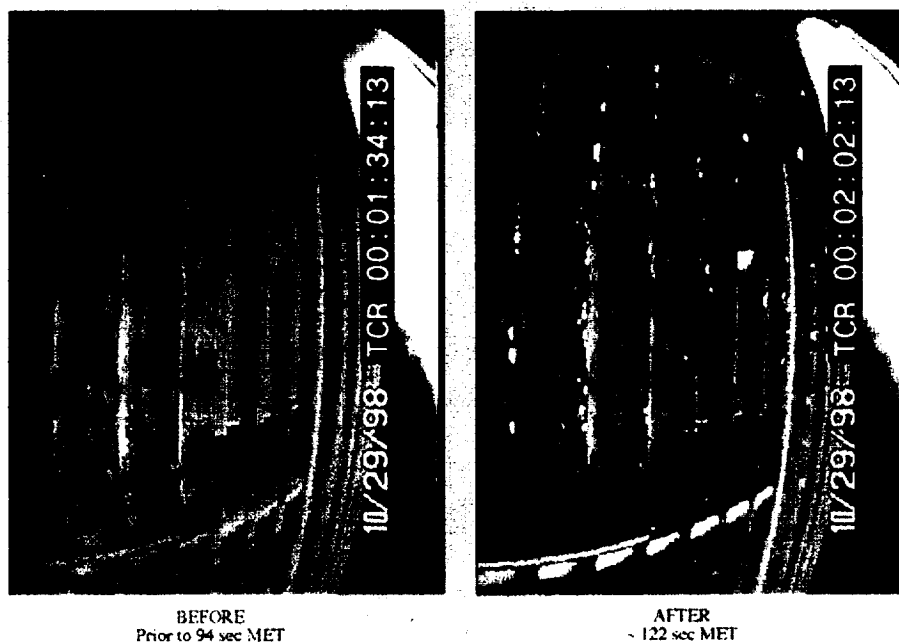
Figure 2.6 (A) ET Thrust Panel Video - Before and After Ablation

Excellent quality video of the ET thrust panel was acquired from the left SRB camera. Multiple small divots, most less than one inch in size, were seen to form on the STS-95 -Y ET Thrust Panel video between 92 and 120 seconds MET. See the "before and after" views shown on Figure 2.6 (A). The majority of the divots occurred on the top surface of the rib heads. The divots were shallow and no exposed substrate was detected. Also, a darkening of the TPS along with a more coarse appearing texture of the TPS caused by the ablation of the TPS surface material is apparent on the "after" view. For scale reference, the visible star (*) patterns painted on the thrust panel rib heads are one inch in size and are spaced at 5.5 inch intervals along the rib heads in the X axis direction.

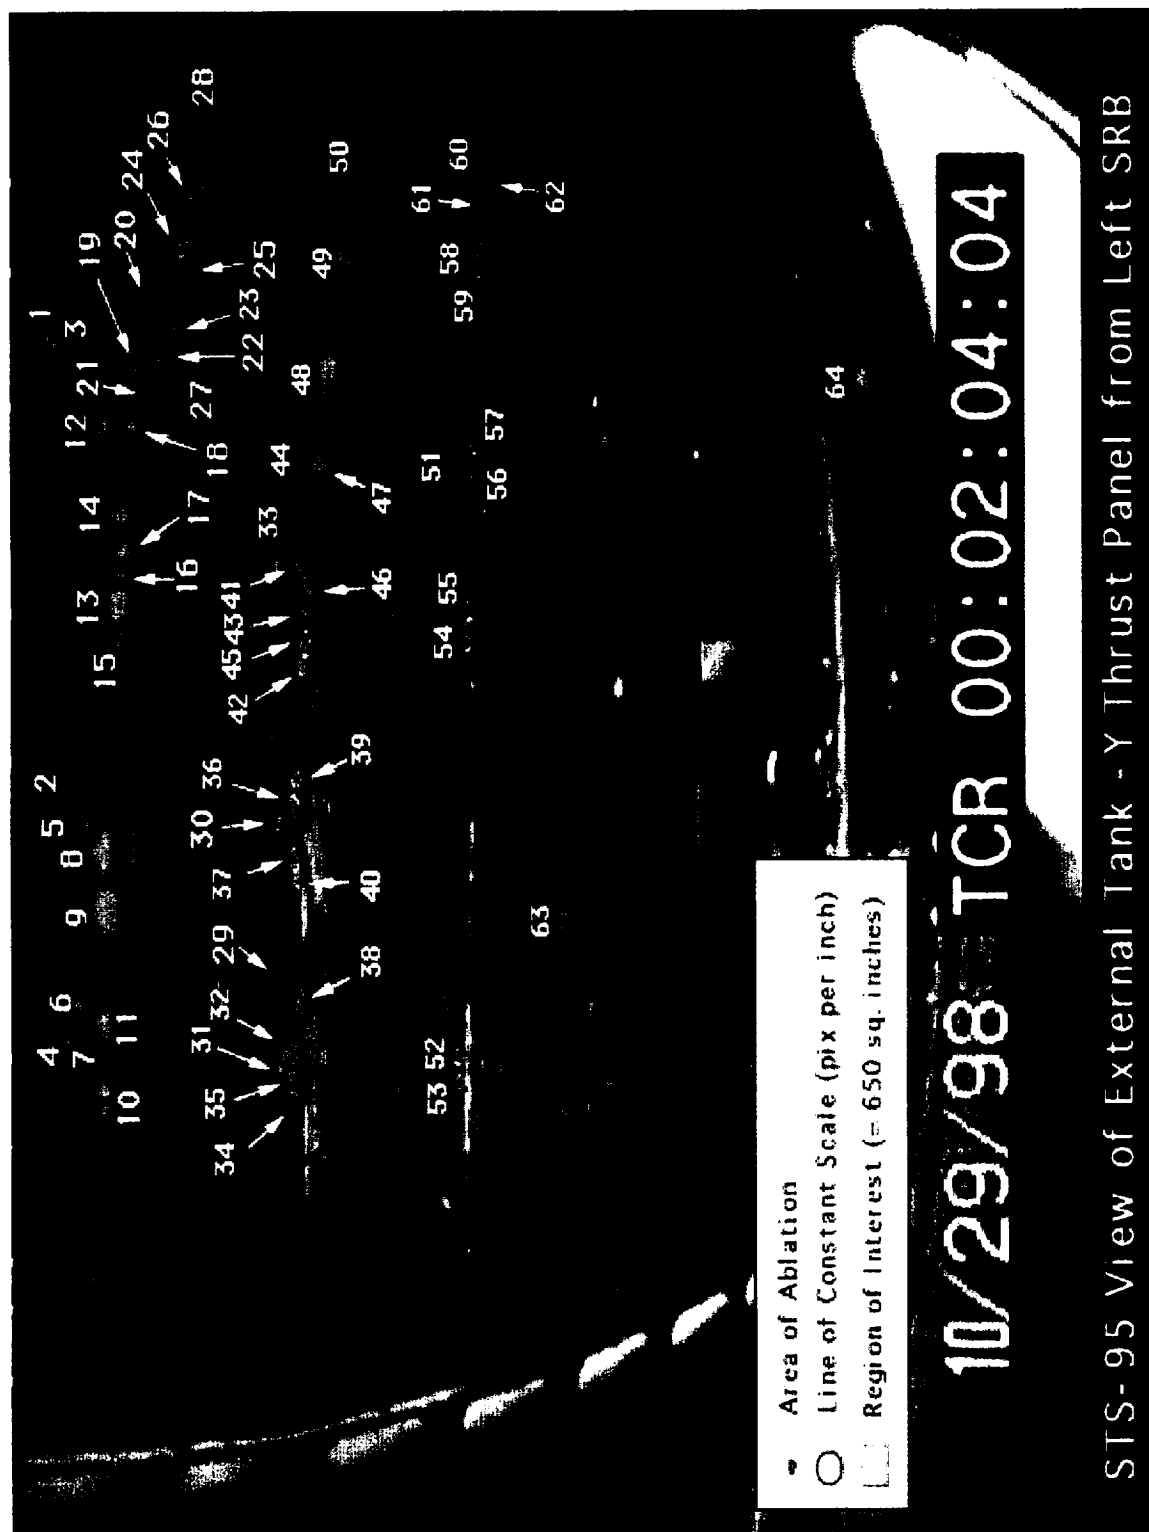
Figure 2.6 (B) -Y Thrust Panel Measurement Area

Sixty-four areas of ablation larger than 0.1 inches in diameter were identified on the surface of the External Tank -Y Thrust Panel video view. This ablation began 30 seconds prior to SRB separation. Using a variable image scale derived

Each ablation area is expected to have created a similarly sized particle, with a few exceptions. Five ablation areas were observed to have been created in successive incremental steps, rather than at once, and the smaller sizes of the resulting particles have been noted.

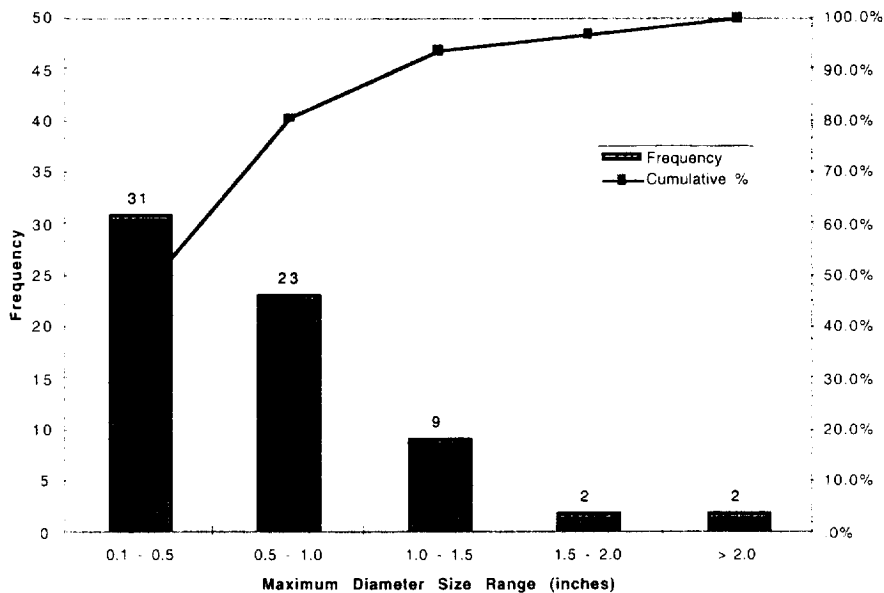
Figure 2.6 (C) Size Distribution for Maximum Diameter of Particles Originating from STS-95 External Tank -Y Thrust Panel Ablation.

The histogram shown in Figure 2.6(C) gives the frequency of particles having maximum diameters that fall within the specified ranges. Three ablation features (IDs 1, 3, 64) were outside the predefined region of interest and were not included in the histogram. A complete list of the maximum and mean diameter measurements for each particle is provided in Table 2.6.

It should be noted that the count for particles smaller than 0.5 inches is not a complete count for features within this size range. Also, the selected area of interest includes surface areas that are hidden from view. These areas constitute the sides of the rib-like stringers oriented horizontally in the image. While these

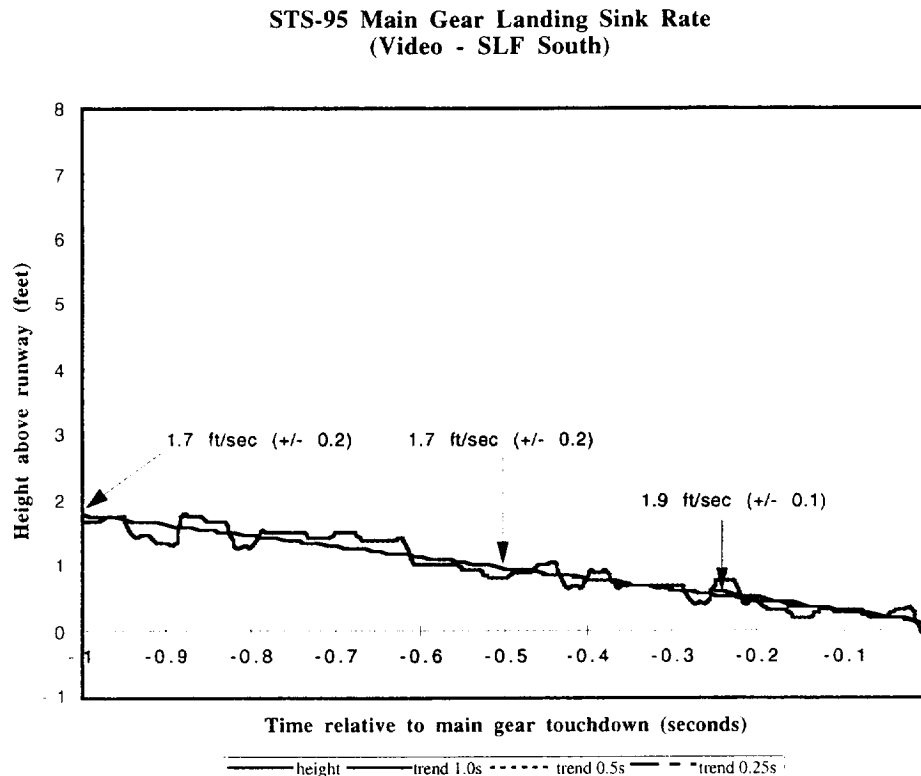
Figure 2.8.1 Main Gear Landing Sink Rate

The left main gear sink rate for STS-95 landing at one second, at half a second, and at a one quarter of a second are provided in Table 2.8.1. A plot describing these sink rate is provided in Figure 2.8.1.

The maximum allowable main gear sink rate values are 9.6 ft/sec for a 212,000 lb vehicle and 6.0 ft/sec for a 240,000 lb vehicle. The landing weight of the STS-95 vehicle was estimated to be 228,639 lbs.
